PERATION

GREENHOUSE

SCIENTIFIC DIRECTOR'S REPORT

ANNEX 3.2 U. S. NAVY STRUCTURES

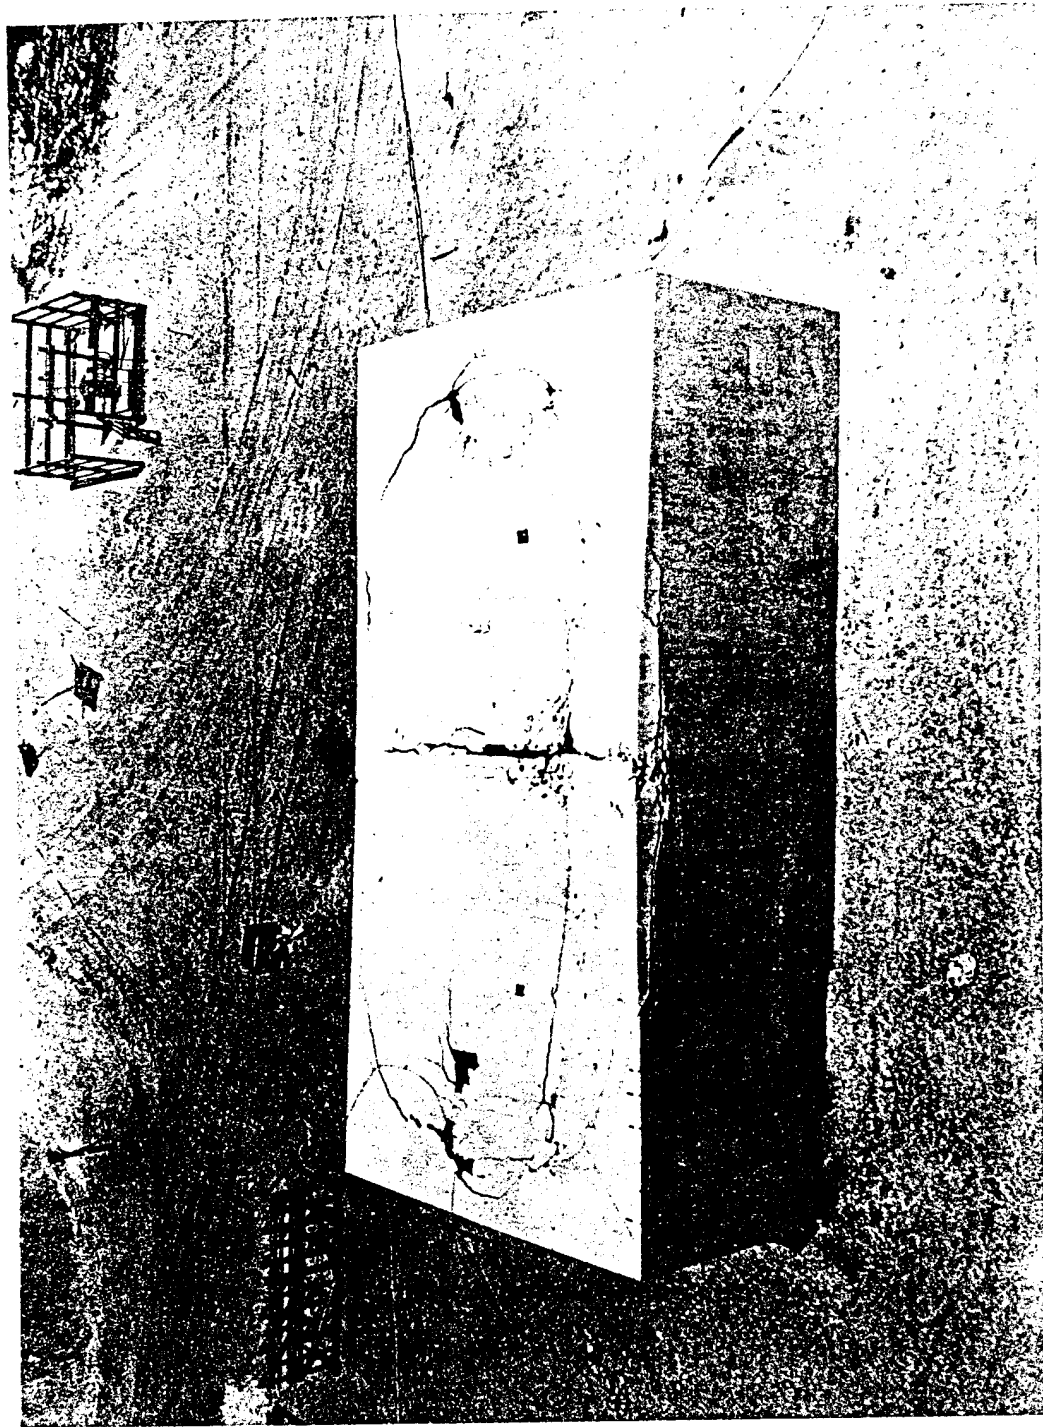
Fig. L.491 Aerial View of Structure after Blast, Structure 3.2. 7b

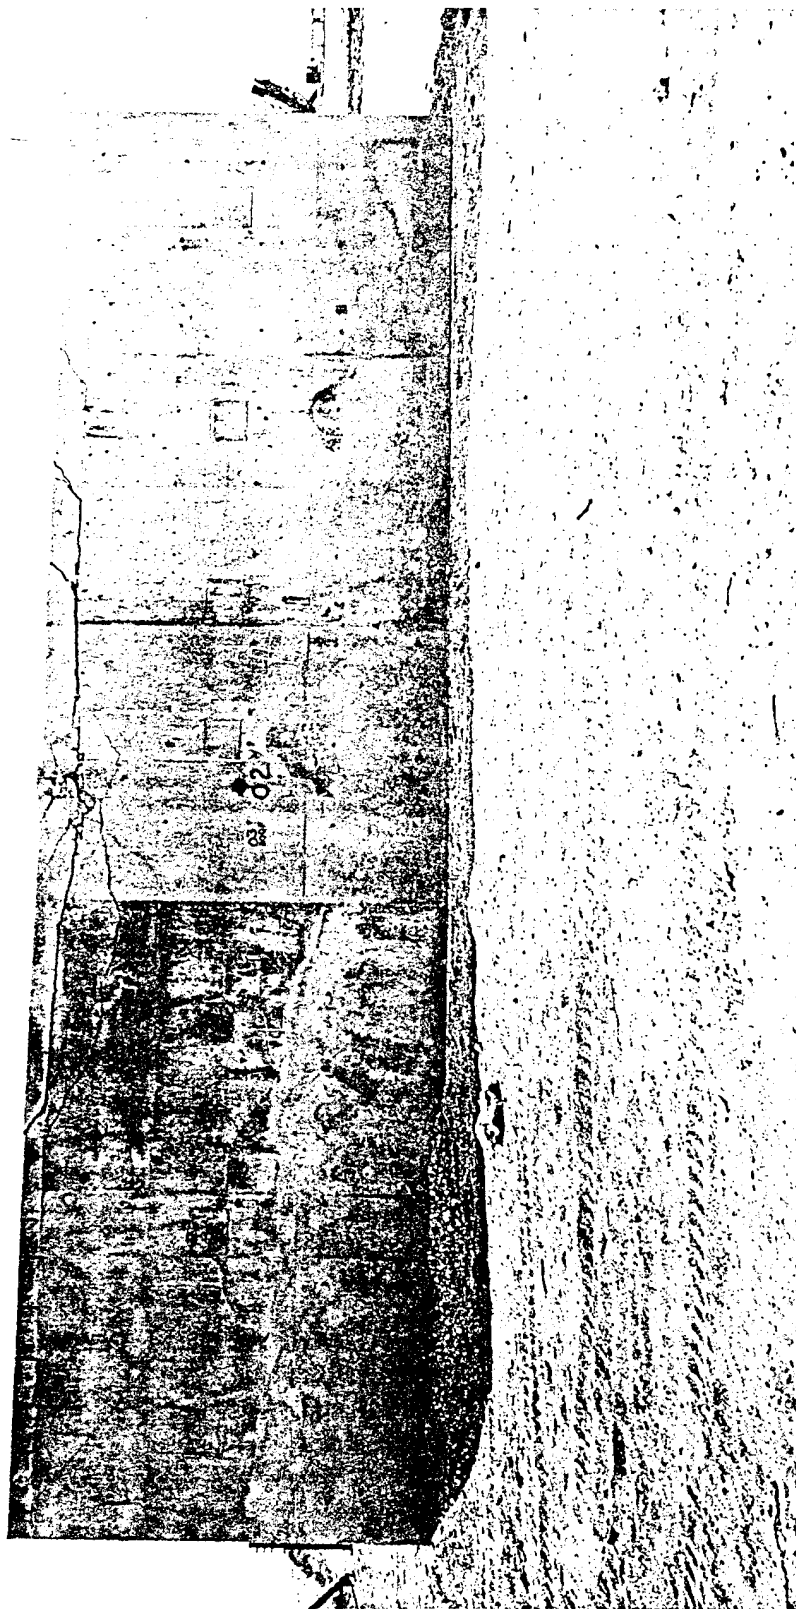
Fig. L. 492 Front Wall after Blast, Structure 3.2. 7b

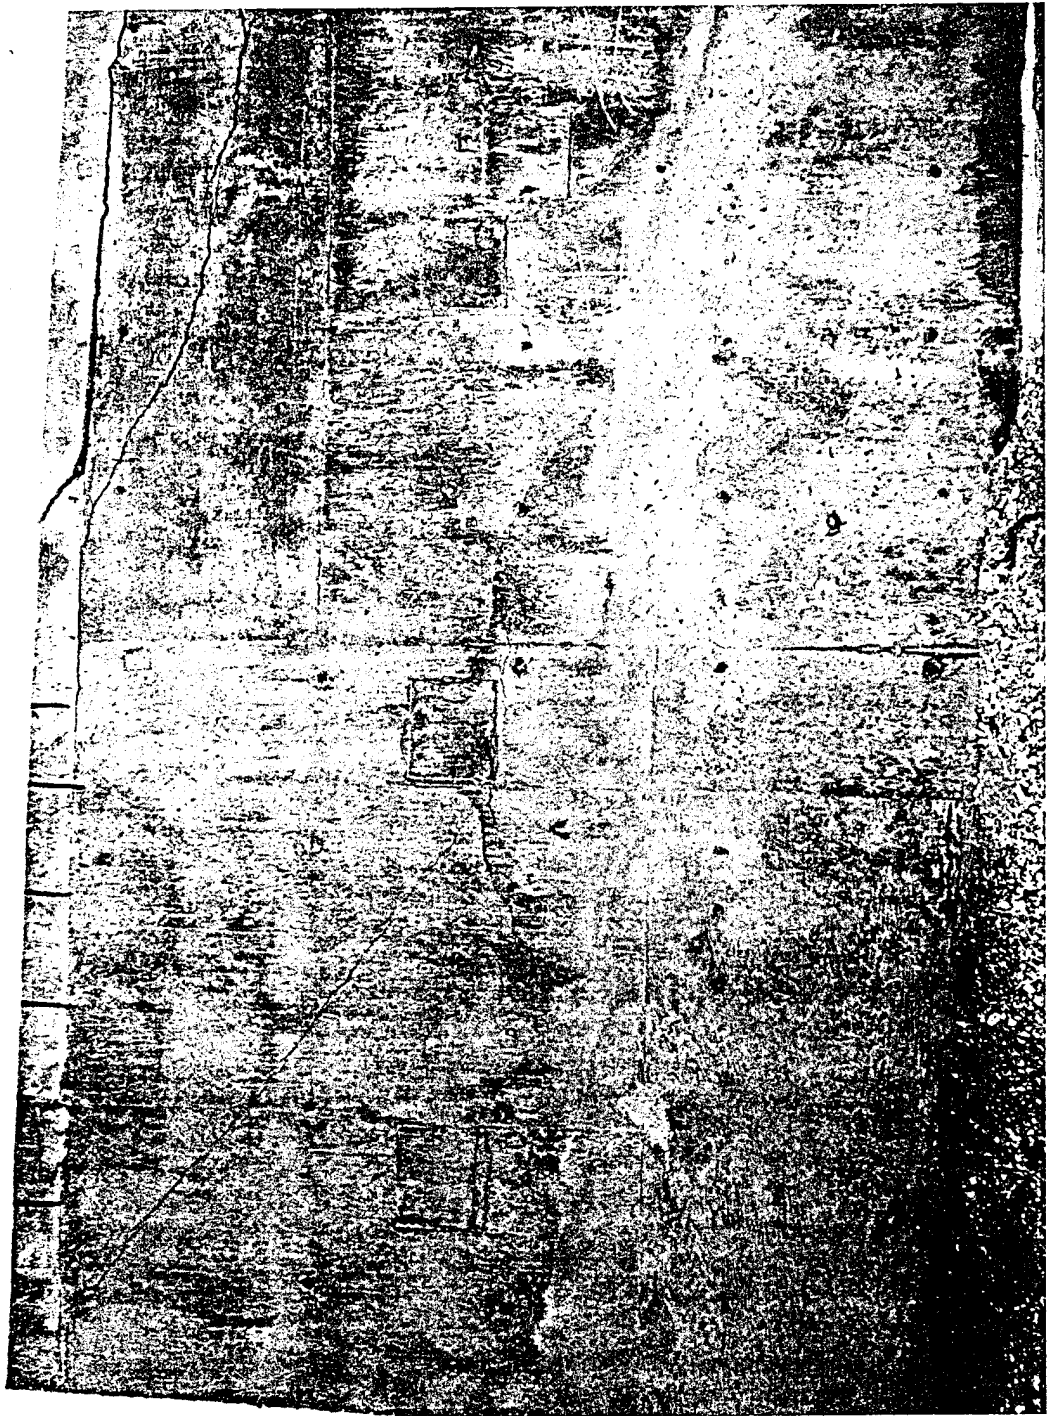
Fig. L.493 Left Half of Front Wall after Blast, Structure 3.2. 7b

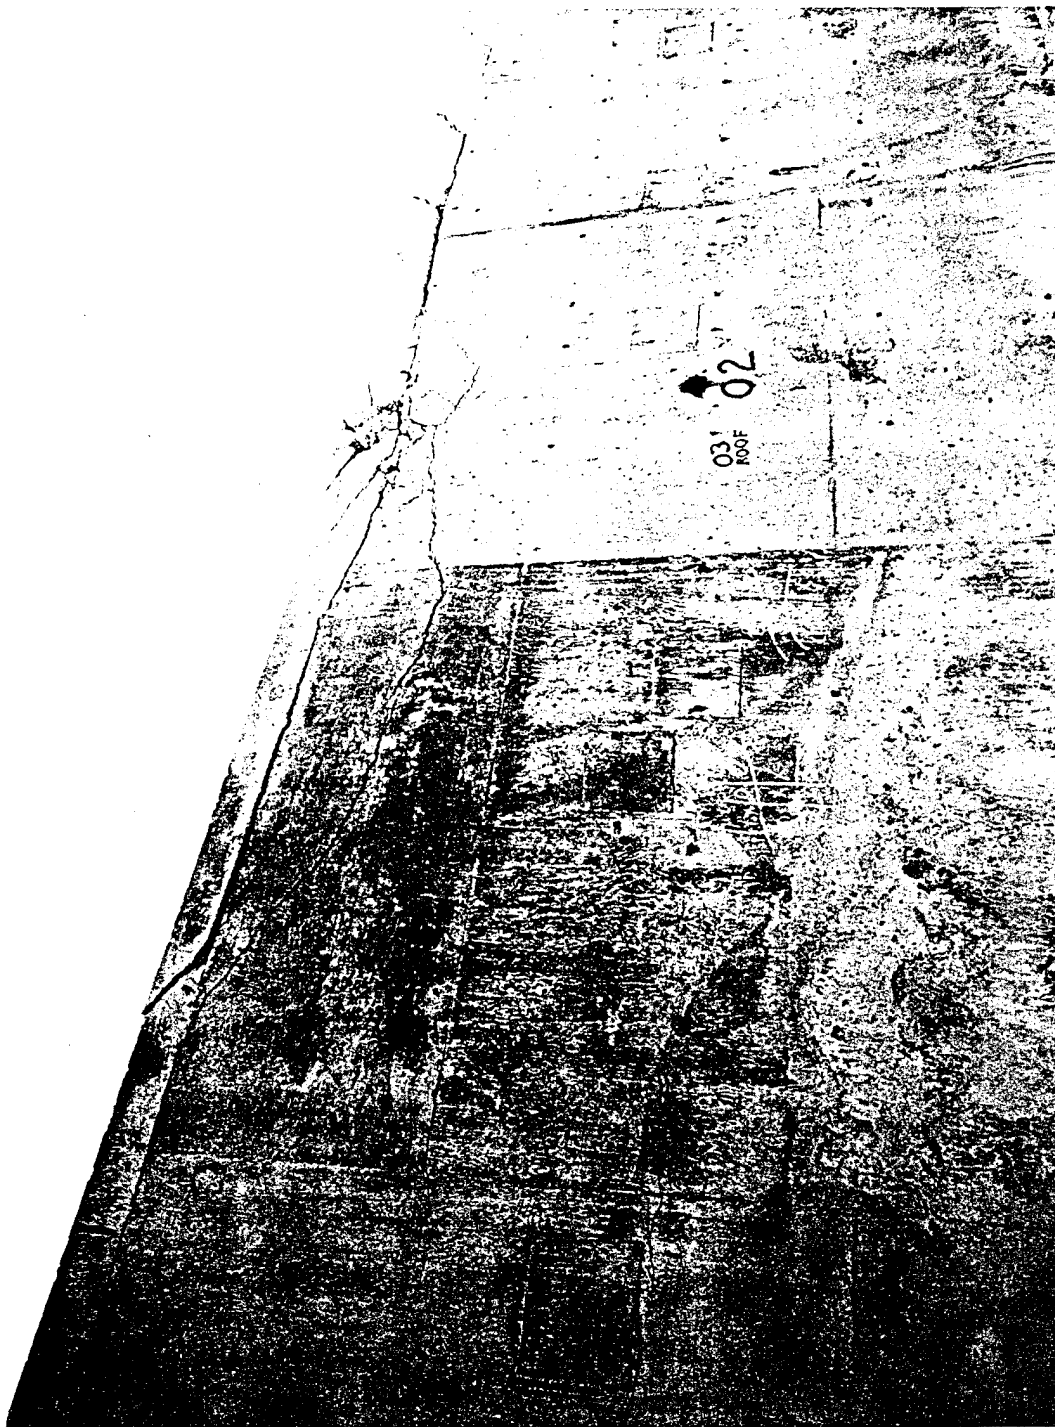
Fig. L.494 Center Portion of Front Wall after Blast, Structure 3.2.7b. Heavy cracking near roof line is clearly visible. Upper 6 in. of the wall bent inward as the main roof girder rotated at the haunch.

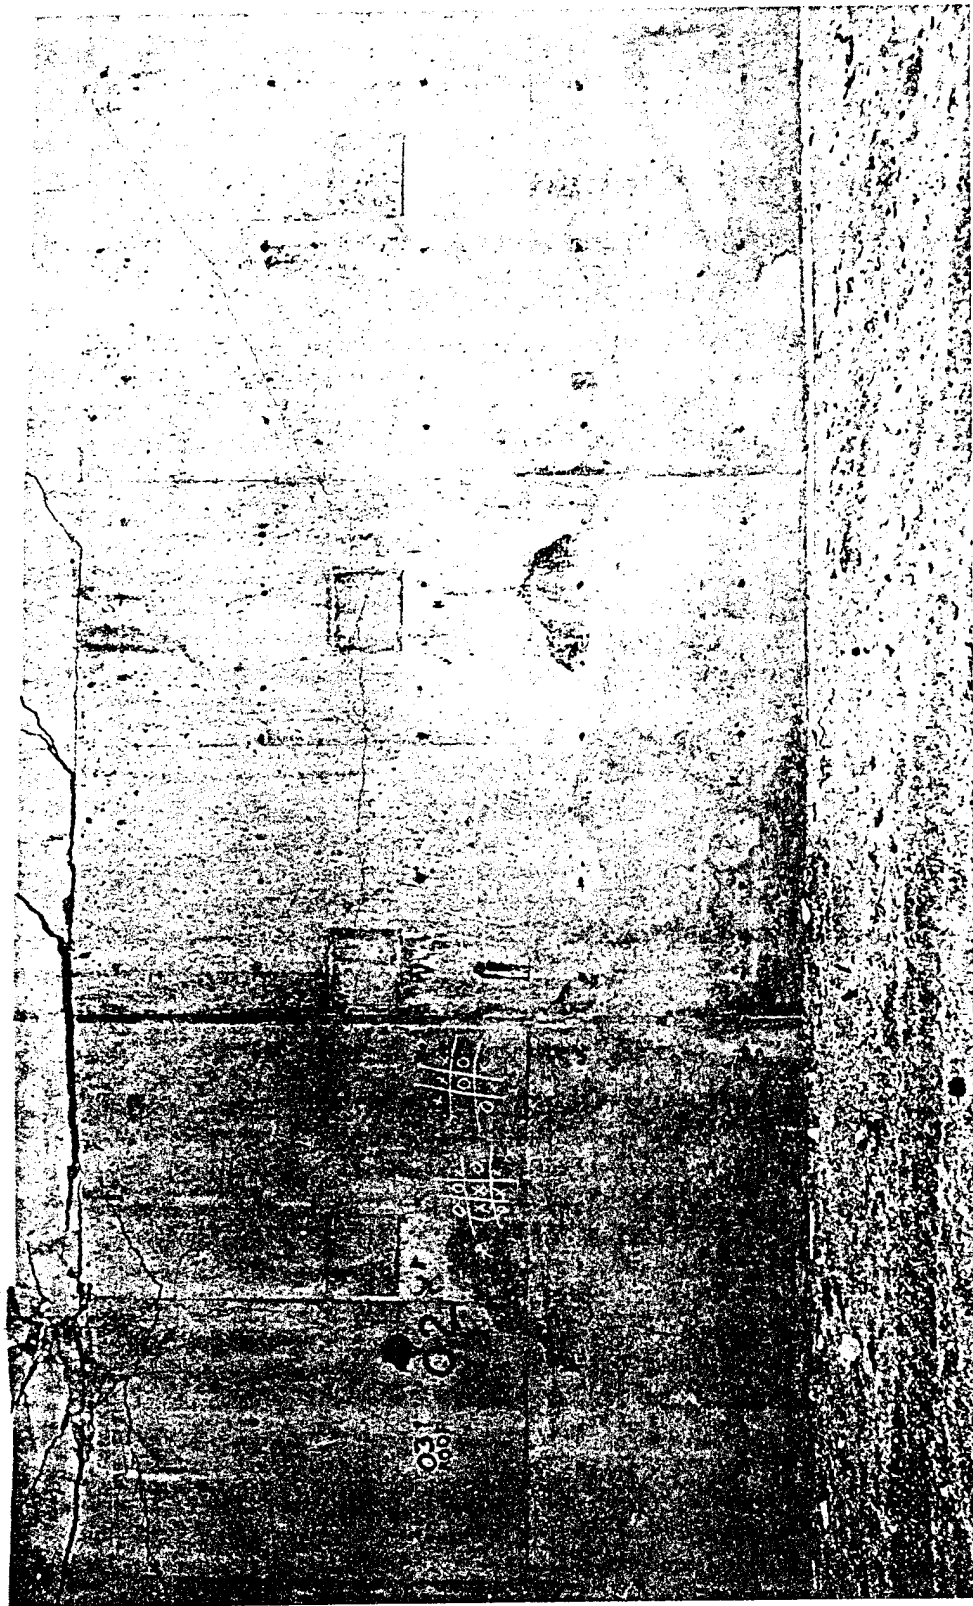
Fig. L. 495 Right Half of Front Wall after Blast, Structure 3.2. 7b

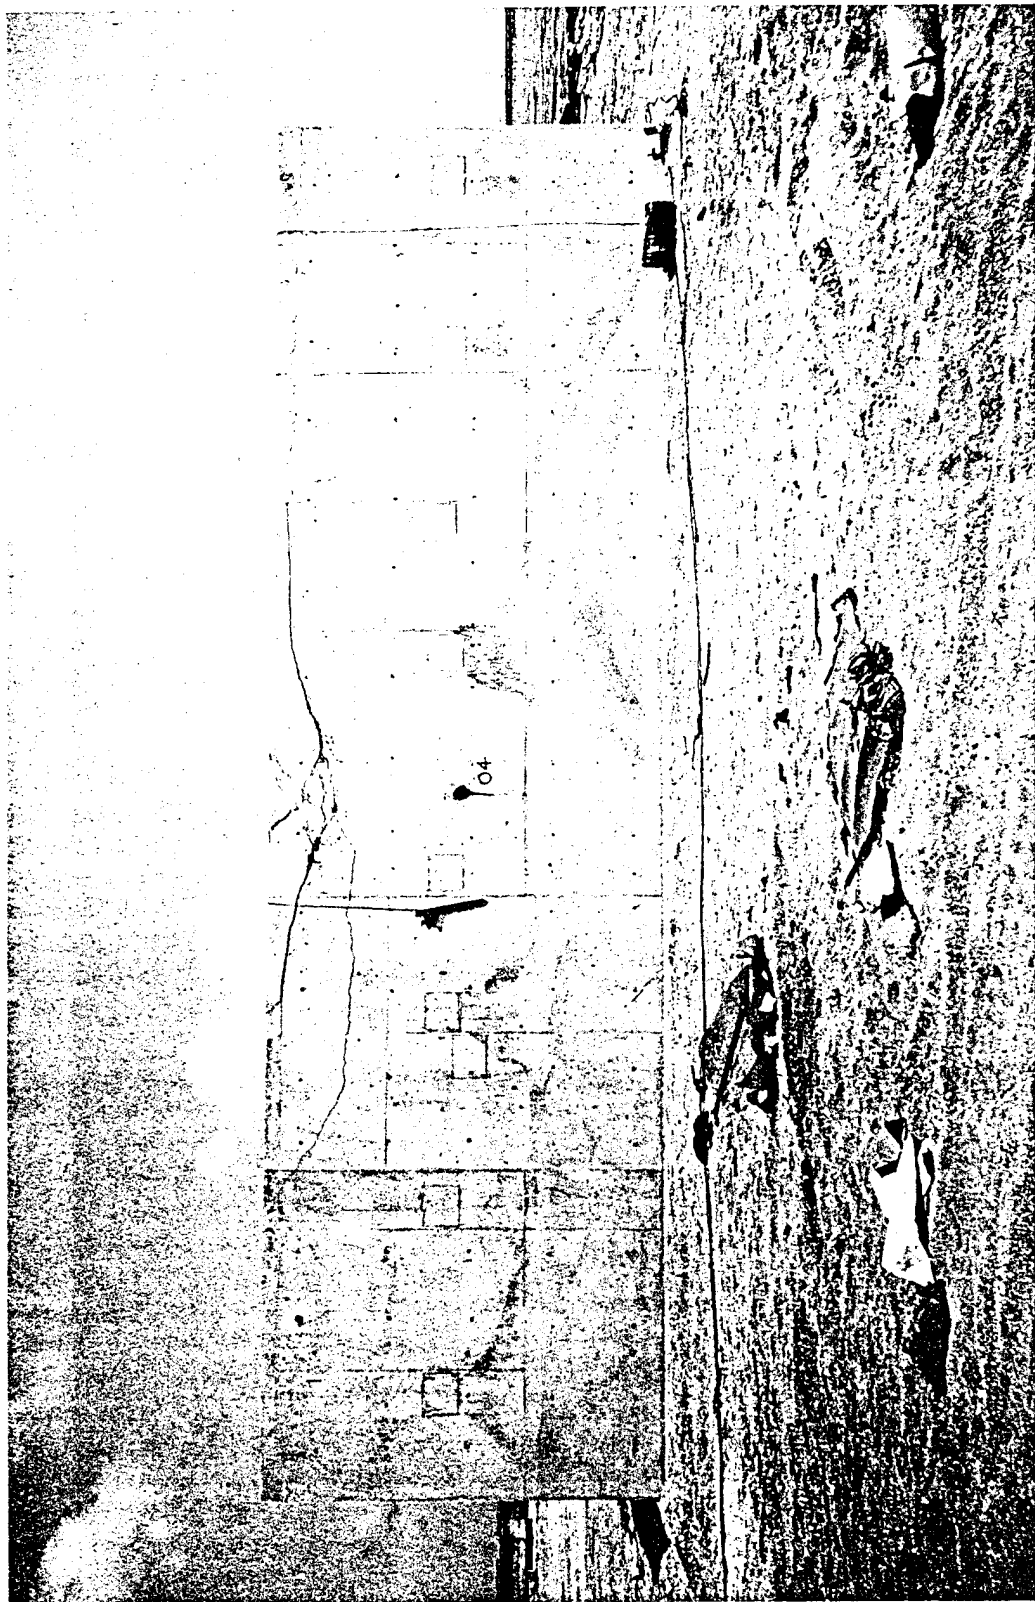
Fig. L. 497 Rear Wall of Structure after Blast, Structure 3.2.7b

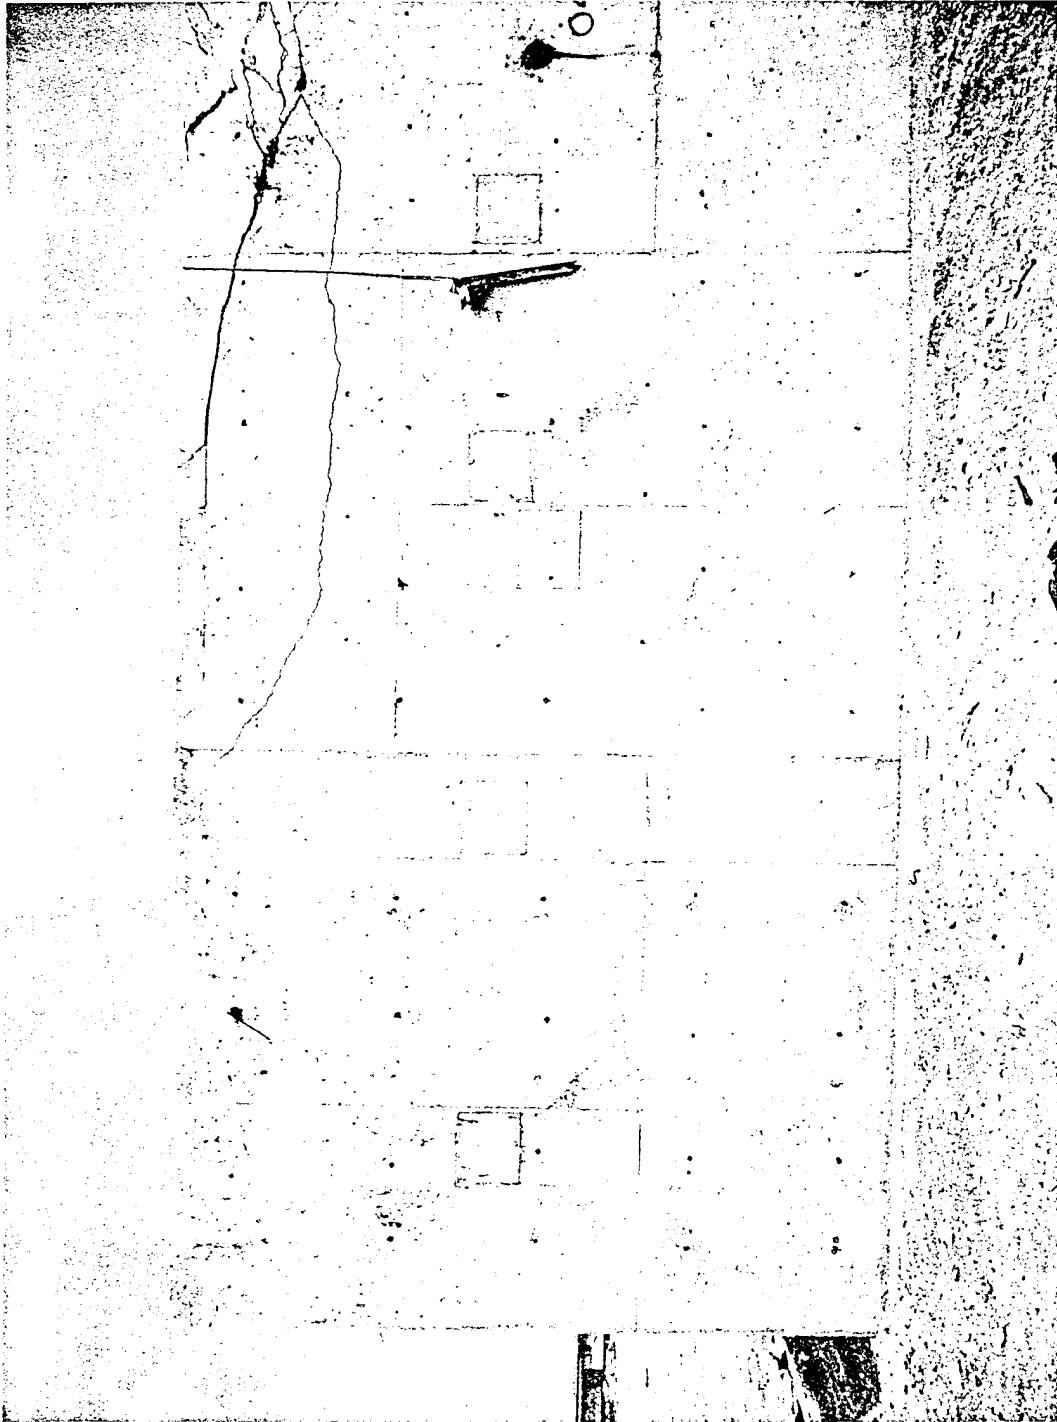
Fig. L.498 Right Half of Rear Wall after Blast, Structure 3.2.7b

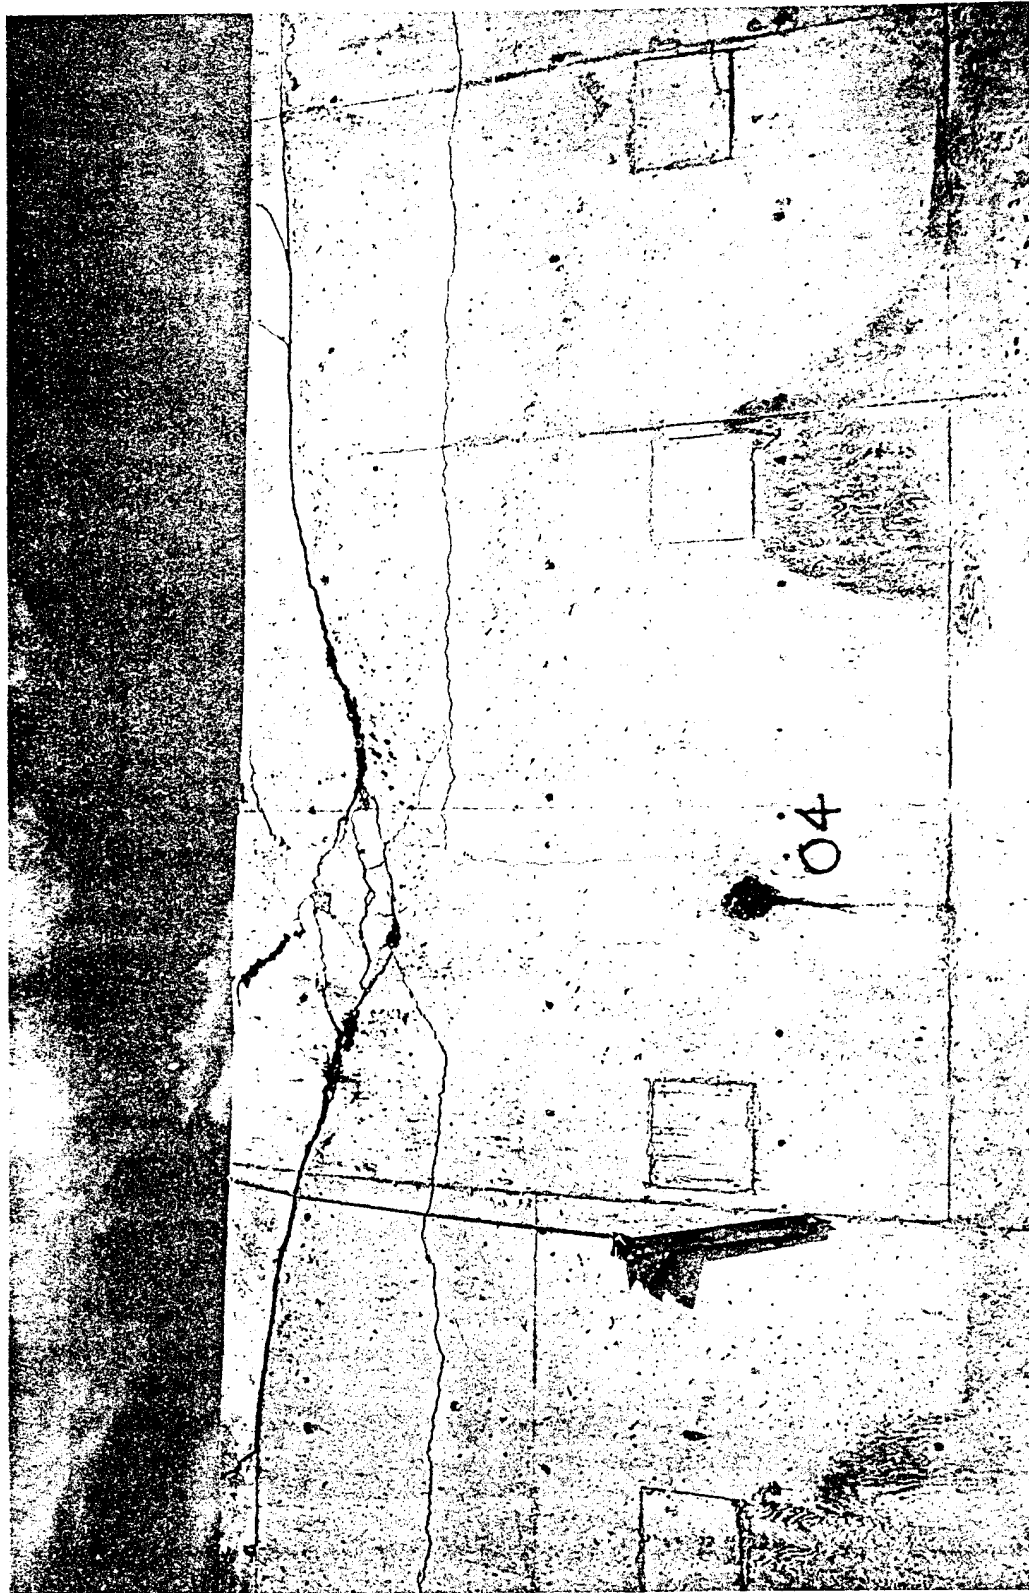
Fig. L. 499 Center Portion of Rear Wall after Blast, Structure 3.2. 7b. Heavy cracking occurred along the construction joint near the roof when the main transverse roof girder rotated at the haunch.

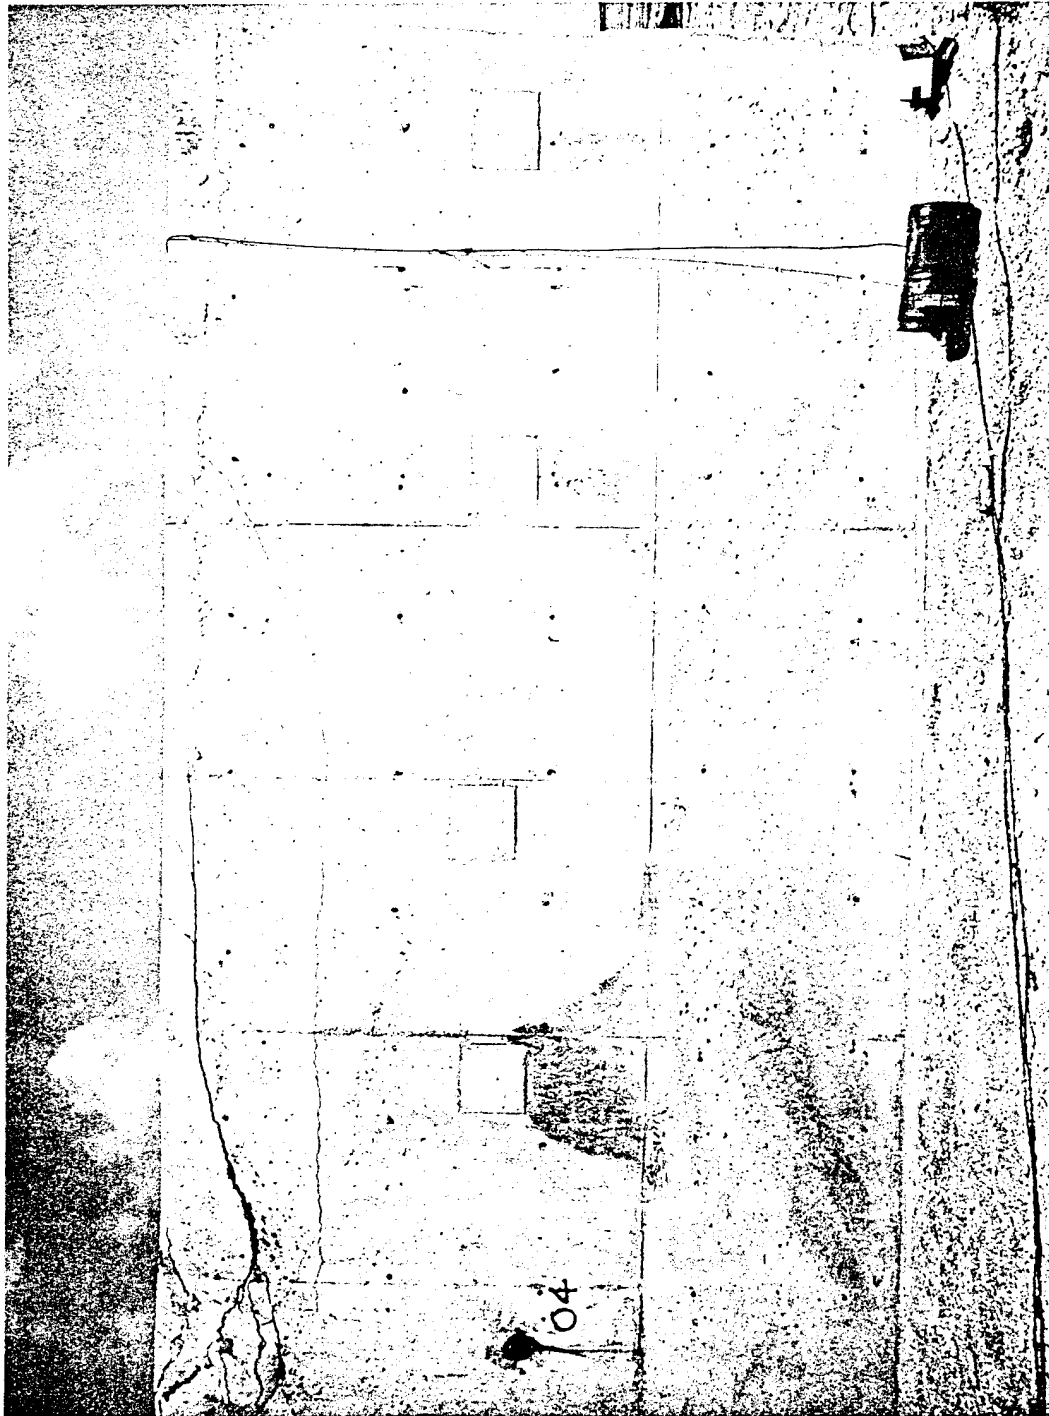
Fig. L. 500 Left Half of Rear Wall after Blast, Structure 3. 2. 7b

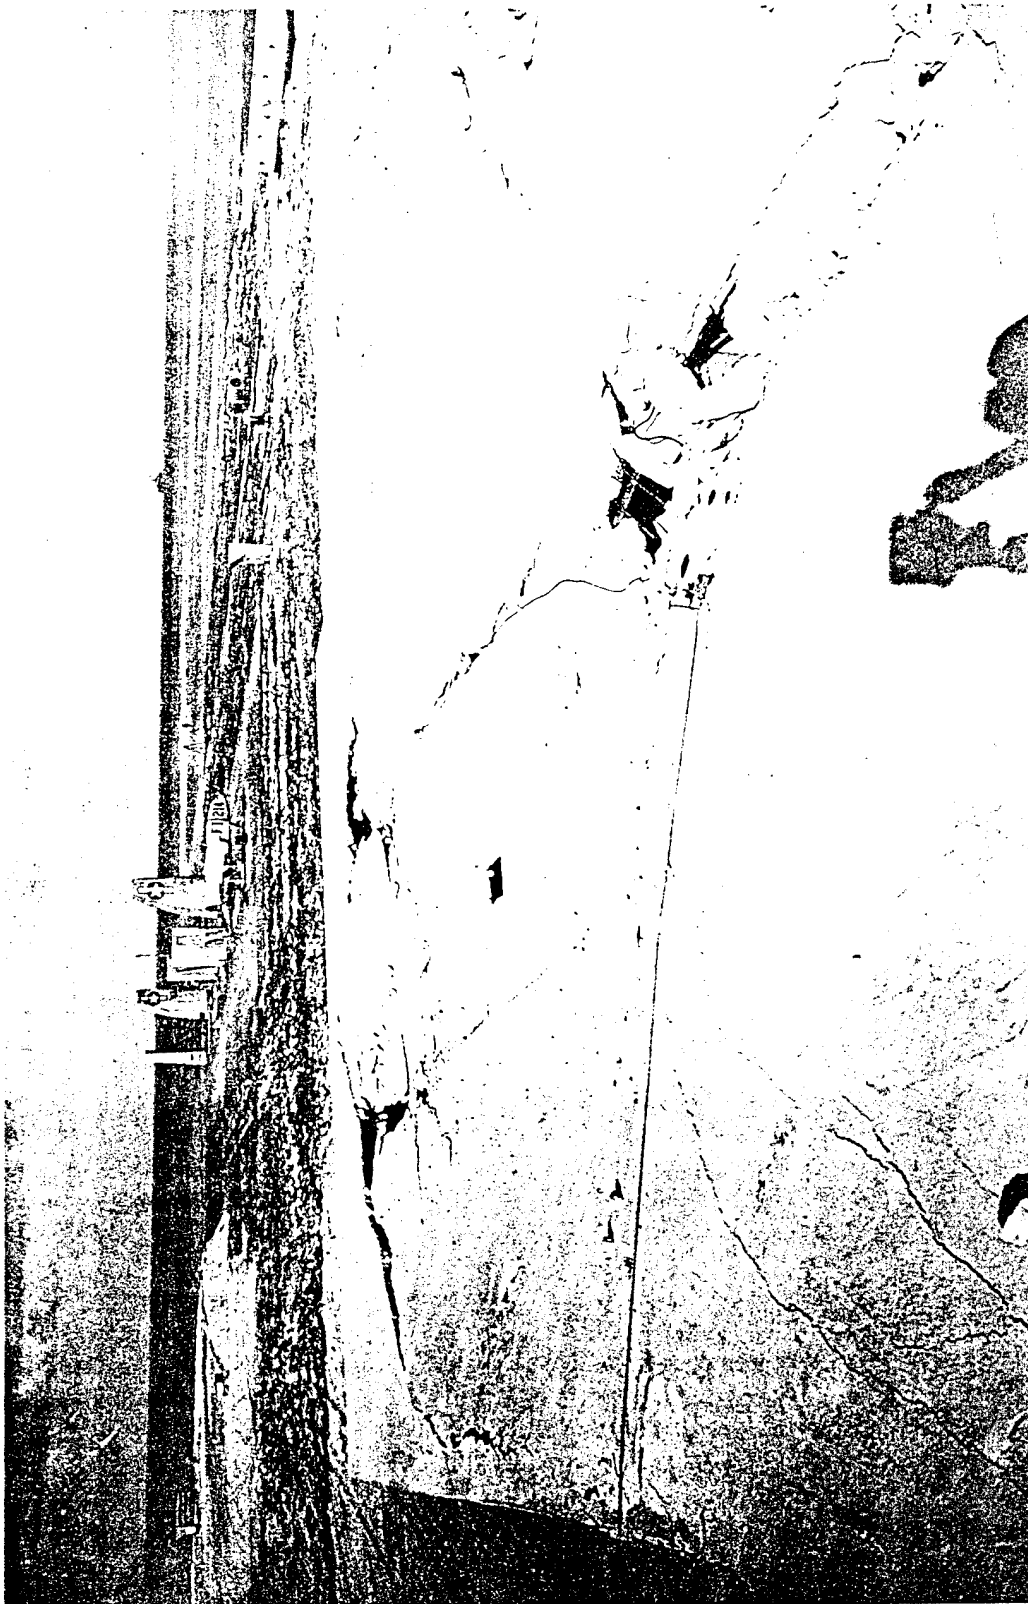
Fig. L. 502 General Exterior View of Roof after Blast, Taken from Left End, Structure 3.2. 7b

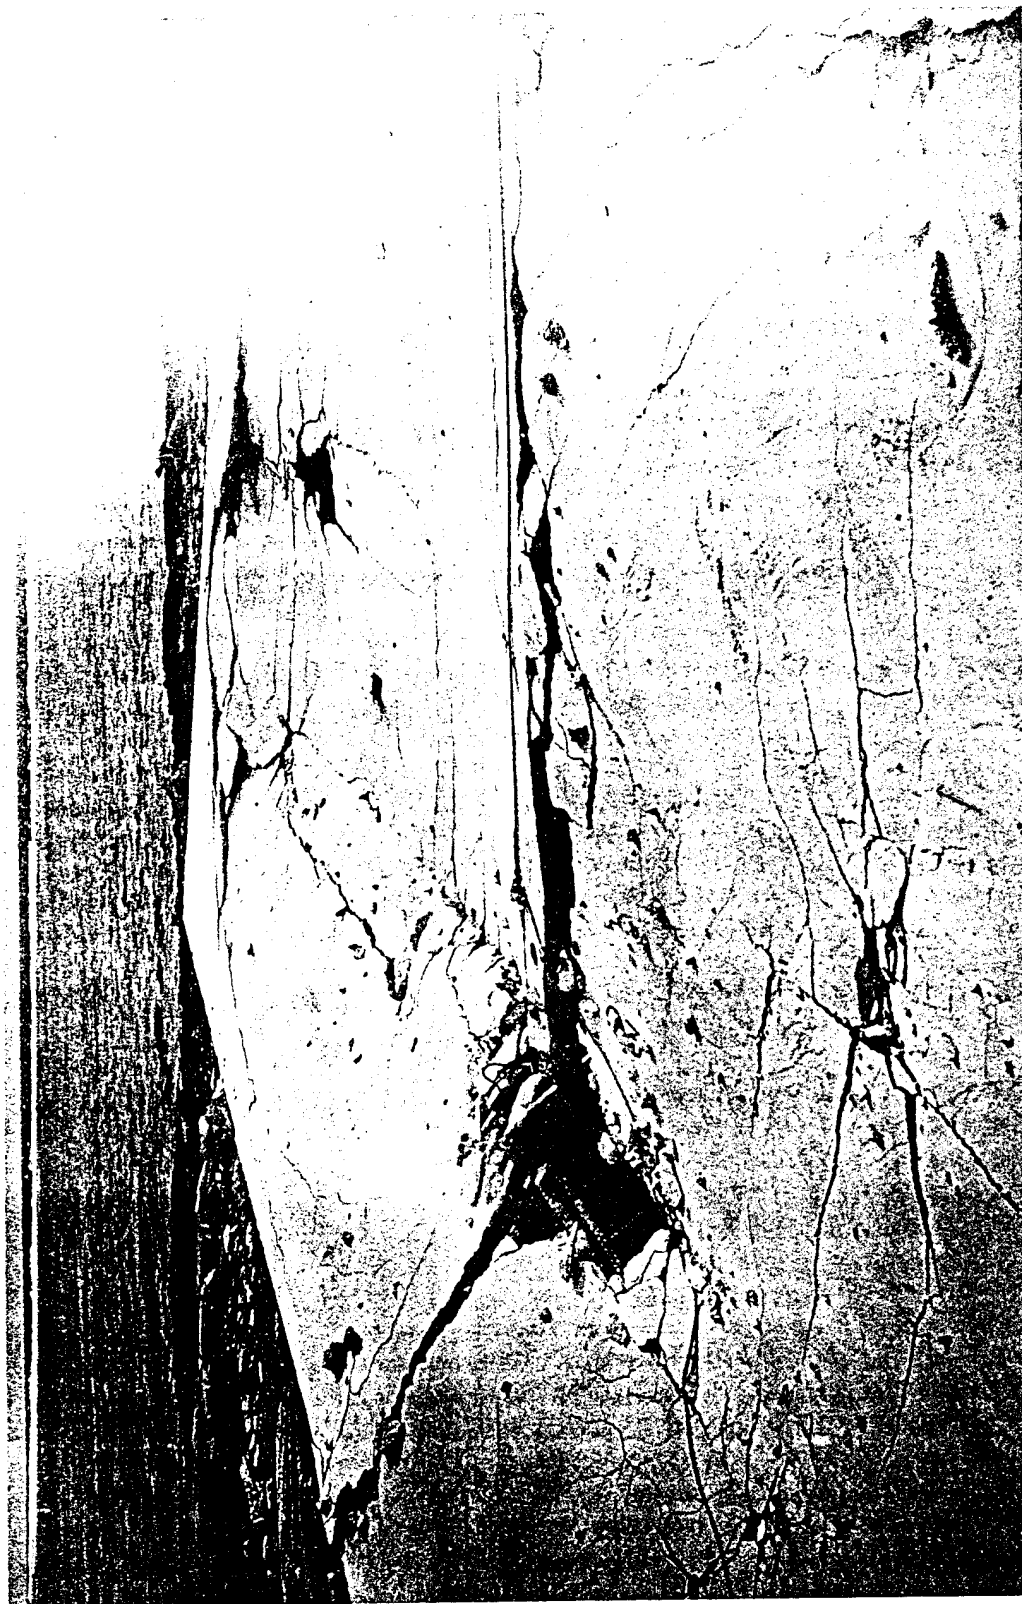
Fig. L. 503 General Exterior View of Roof, Taken from Right End, Structure 3.2.7b. Note the extremely heavy deflection of the main transverse roof girder. Heaviest deflections along the longitudinal axis occurred at the line of the forward stringer beams.

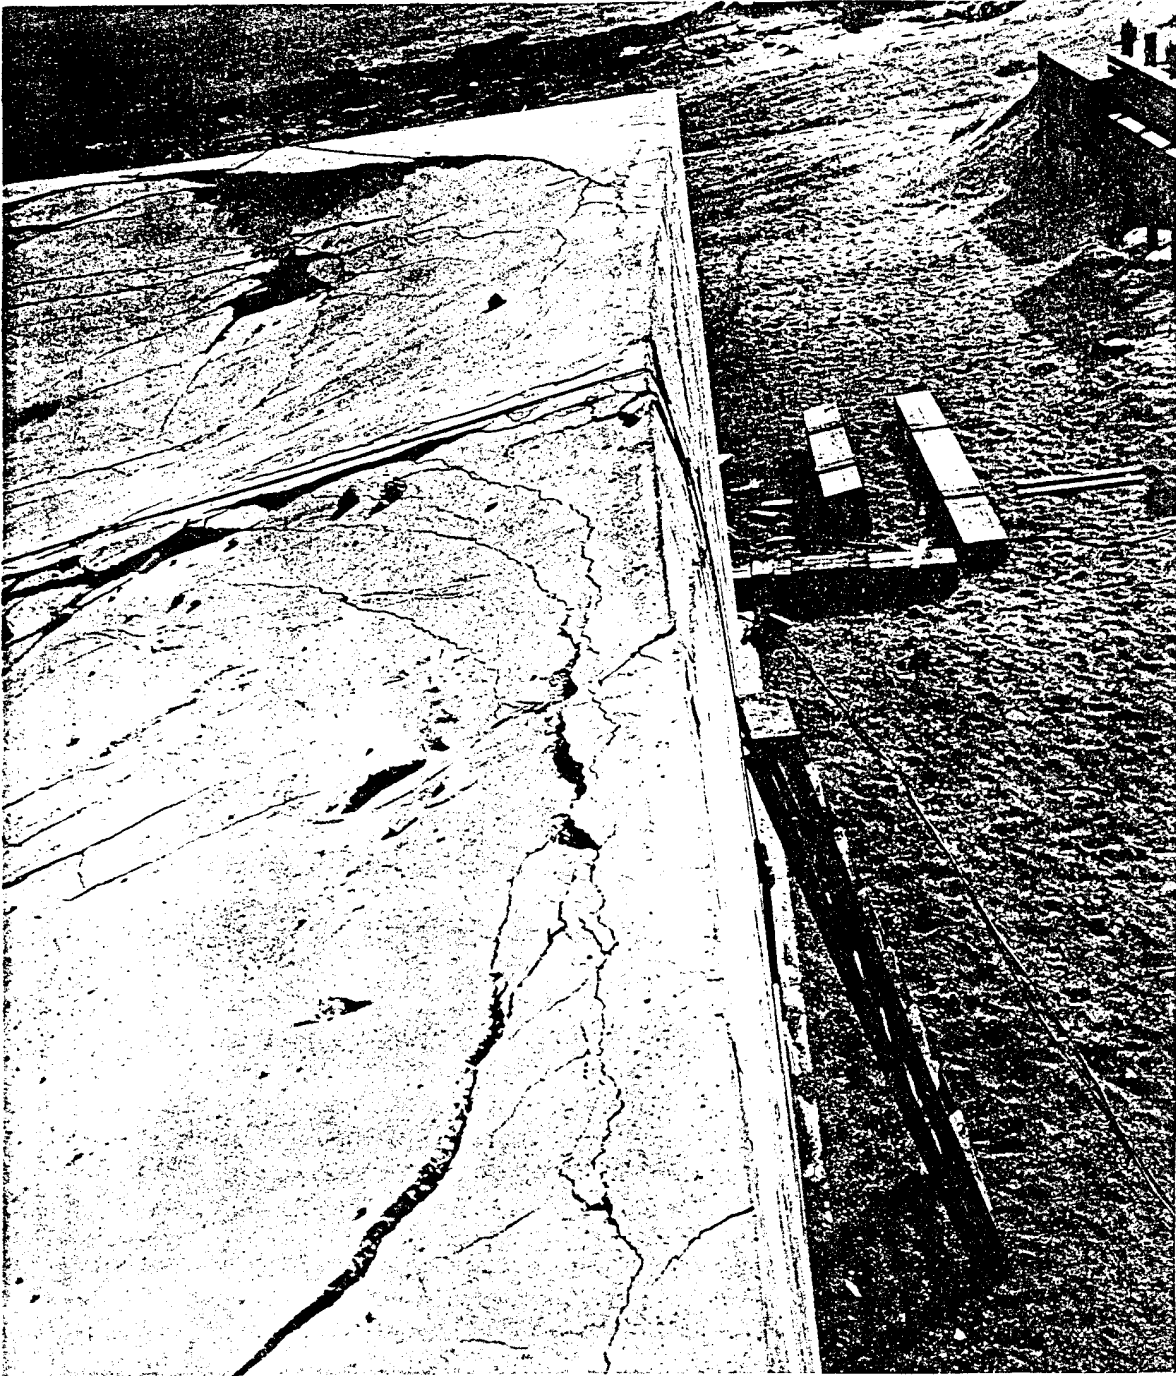
Fig. L. 504 View along Rear Edge of Roof, Structure 3.2. 7b. Deflection pattern of rear wall can be seen; it is a maximum at the roof level.

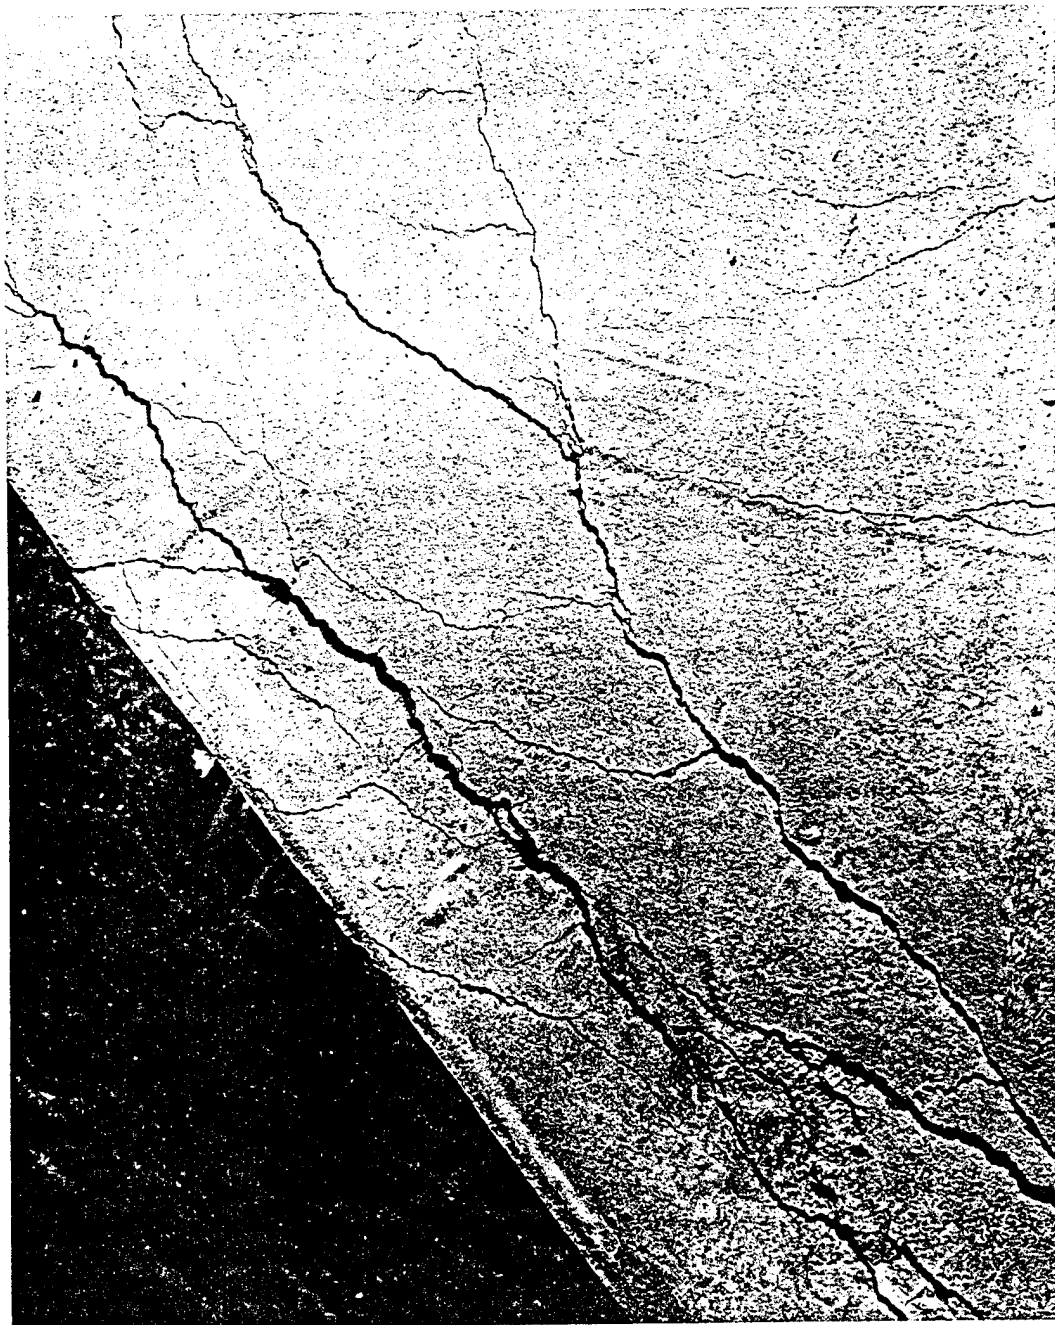
Fig. L. 505 Detail View of Cracks in Roof along Rear Edge on Left Half of Roof, Structure 3.2. 7b

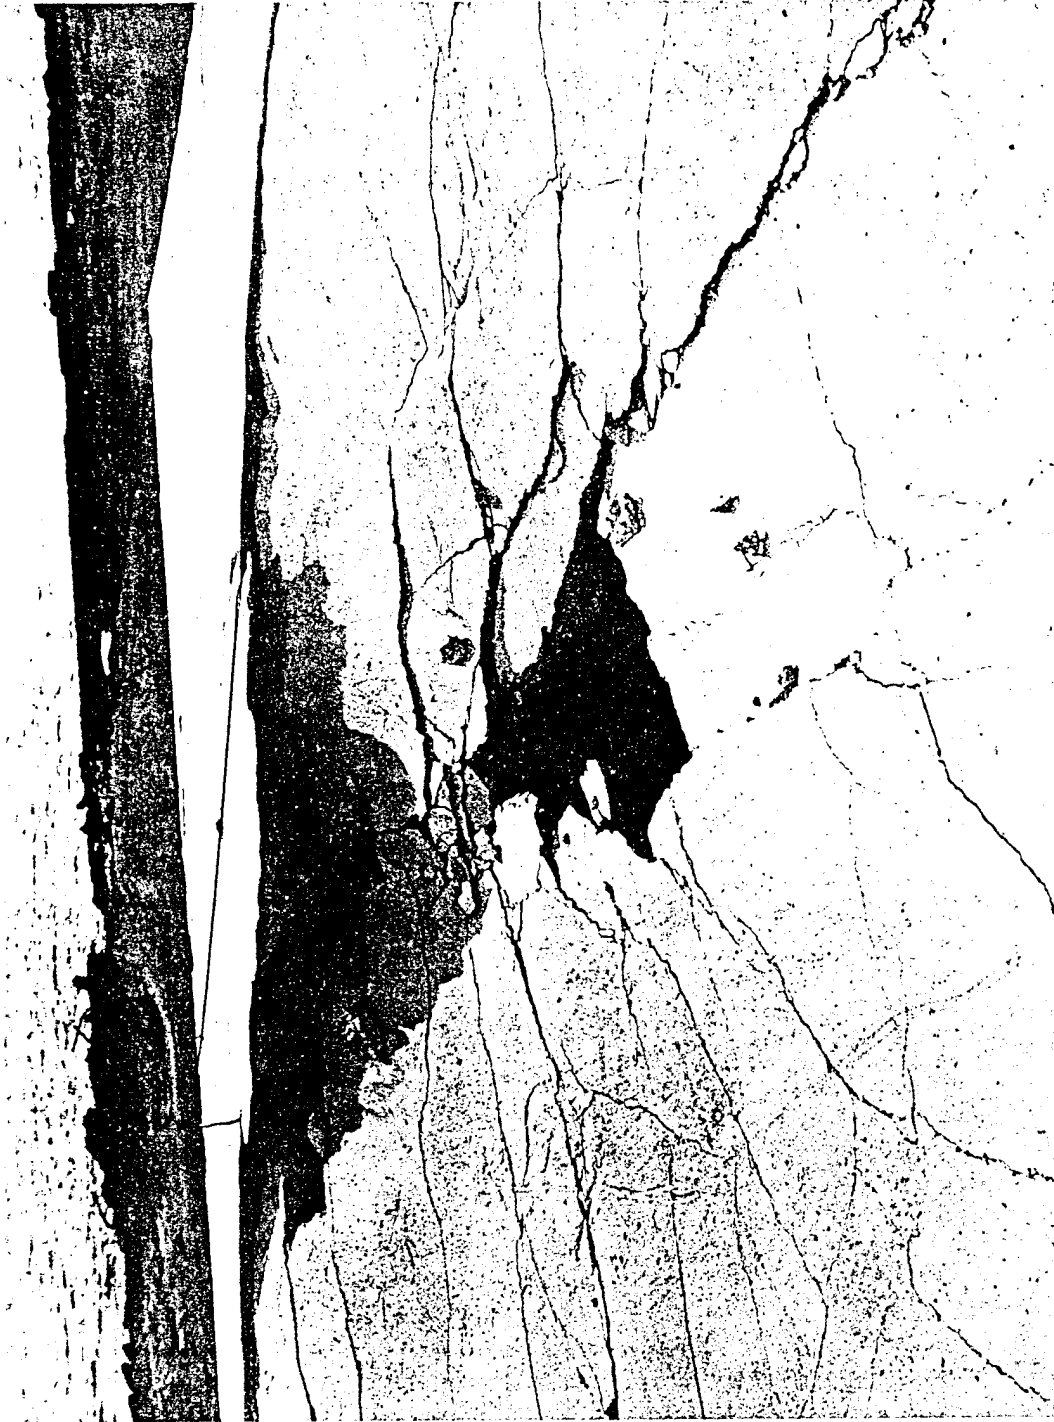
Fig. L. 506 Cracks and Holes in Concrete Roof Slab at Left Rear Corner, Structure 3. 2. 7b. Note that the reinforcing steel is still holding up the roof.
